**NFRC 201-2004 SOLAR HEAT GAIN COEFFICIENT
TEST REPORT**

CLEAR FOCUS IMAGING

SERIES/MODEL: ImageVue®

Report No: 99451.04-301-41
Test Date: 03/22/10
Report Date: 04/14/10
Revision 1 Date: 04/30/10
Record Retention Date: 03/22/14

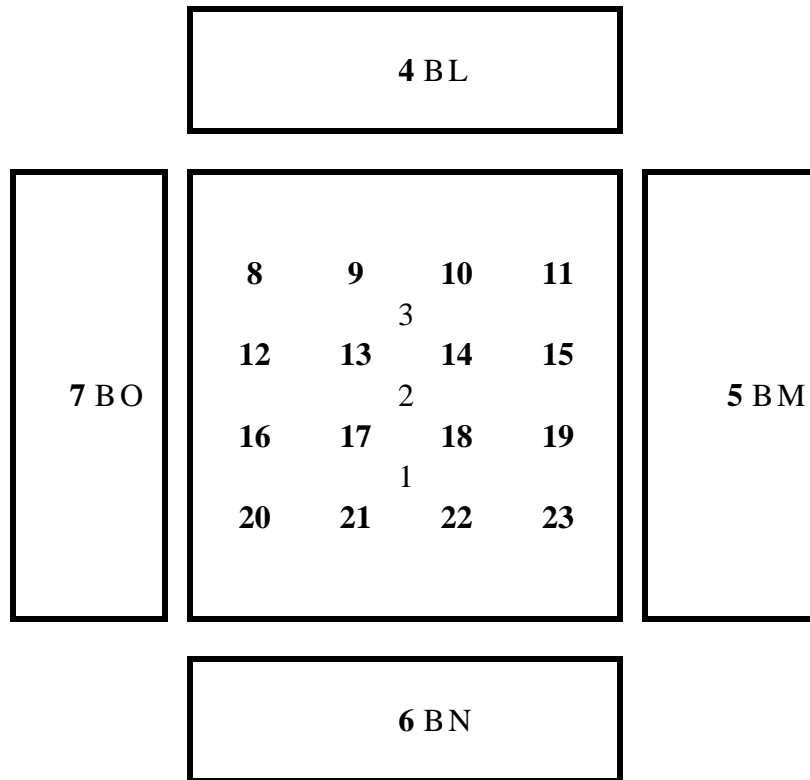
Thermocouple Locations

Absorber Plate Thermocouple Layout

*Note: See Appendix A for locations

Air Top	1	Heat Exchanger	72.2 F
Air Center	2	Heat Exchanger	72.1 F
Air Bottom	3	Heat Exchanger	73.0 F
Location	4	Heat Exchanger	69.0 F
Location	5	Heat Exchanger	68.5 F
Location	6	Heat Exchanger	68.4 F
Location	7	Heat Exchanger	68.9 F
Location	8	Heat Exchanger	67.9 F
Location	9	Heat Exchanger	68.0 F
Location	10	Heat Exchanger	67.9 F
Location	11	Heat Exchanger	67.9 F
Location	12	Heat Exchanger	68.0 F
Location	13	Heat Exchanger	68.0 F
Location	14	Heat Exchanger	67.9 F
Location	15	Heat Exchanger	67.9 F
Location	16	Heat Exchanger	68.1 F
Location	17	Heat Exchanger	70.8 F
Location	18	Heat Exchanger	68.2 F
Location	19	Heat Exchanger	0.0 F
Location	20	Heat Exchanger	71.3 F
Location	21	Heat Exchanger	68.7 F
Location	22	Heat Exchanger	68.6 F
Location	23	Heat Exchanger	67.8 F
Location	24	Heat Exchanger	69.6 F
Location	25	Heat Exchanger	68.1 F
Location	26	Heat Exchanger	68.1 F
Location	27	Heat Exchanger	68.8 F
Location	28	Heat Exchanger	69.3 F
